US Environmental Protection Agency
Region II
EXPEDITED REMOVAL ASSESSMENT CRITERIA

<i>SITE NAME</i>	MPF Inc.				
<i>Date of Report</i>	9/10/98	<i>Removal Eligible (yes/no)</i>	Yes	<i>Site ID No.</i>	N/A
<i>CERCLIS NO.</i>	N/A	<i>RCRIS NO.</i>	N/A

<i>Location:{street, block, lot, city, county, state, zip code,Longitude, Latitude}</i>	890 Paterson Plank Road Bergen County East Rutherford, NJ		
<i>Mailing Address</i>	Same As Above		
<i>Abandoned (date)</i>	12/97		
<i>EPA Investigators (Name & Phone #)</i>	N. Norrell 732-321-4357 A. Anderson 732-906-6803	<i>Date of Investigation</i>	9/9/98
<i>State Investigators (Name & Phone #)</i>	Hayder Camargo 973-669-3955	<i>Date of State Response</i>	9/9/98
<i>State Case No.</i>	Unknown	<i>NRC Case No.</i>	N/A
<i>ERNS Case No.</i>	N/A		
<i>Contact for Access to Property (facility, state, local) (phone #)</i>	Virginia Scaglione (Top Notch Metal Realty) 201-939-9389 201-939-2129 Hayder Camargo (NJDEP) 973-669-3955 Thomas Brady (NJDEP) 973-299-7571		
<i>Directions to site (narrative) (Enclose copy of map at end of report)</i>	NJ Turnpike North to Exit 16W Route 3 East to Route 120 North Route 120 North is same as Paterson Plank Road West Facility

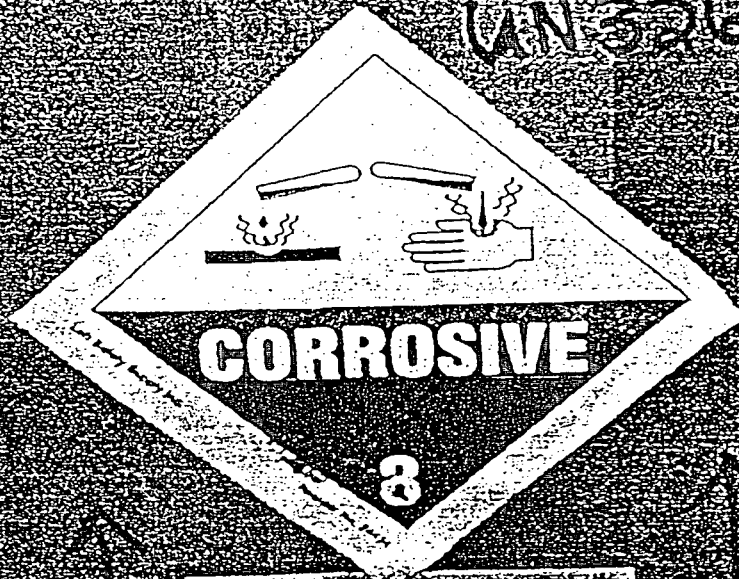
INNER PACKAGES

NEUTRALIZATION TRANSFER

WASTE WATER - C.A.S. 7732-18-5
SODIUM HYDROXIDE - C.A.S. 1310-73-2
SULFURIC ACID - C.A.S. 7664-93-9

CONTAINS METAL HYDROXIDES
CONTENTS PARTIALLY UNKNOWN
CORROSIVE

301B
